## Jetty & Groynes Restoration Project Example

Managed by: Cliff Juillerat

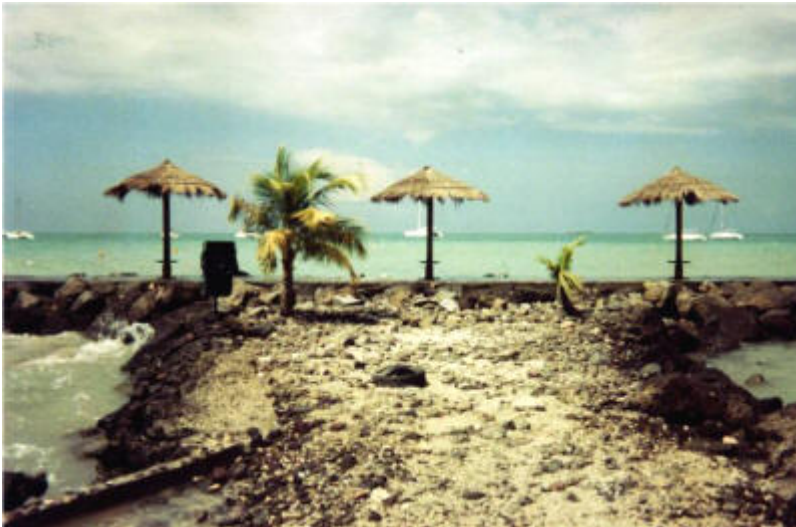
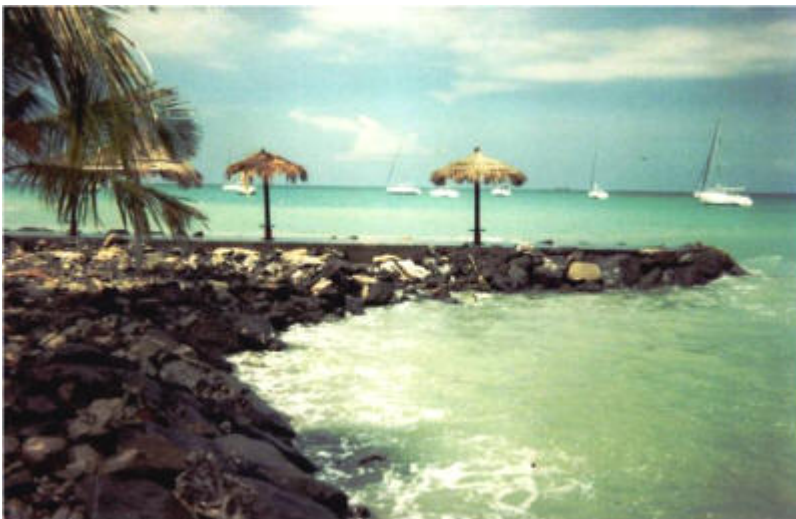
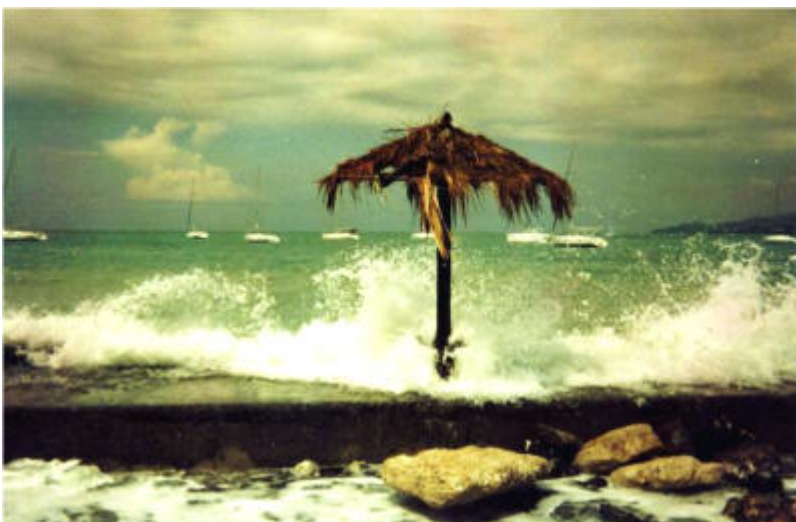
◀ The photos on this page were taken by the GM of the hotel Le Meridien in Martinique, 3 days after a hurricane struck. -- The jetties and groynes were almost completely destroyed.

This problem might not have been so severe had the coastal engineer not utilized the wrong size rock armour (boulders).

As well, the boulders had been improperly placed nor properly interlocked so as to increase the strength and longevity of the structure.

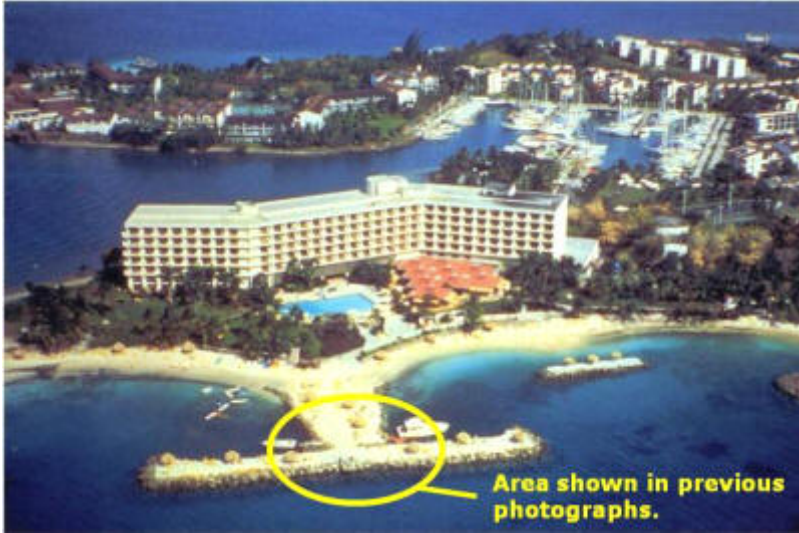
◀ This photo shows the same area near the end of the reconstruction project. At this stage, new sand has been placed on the jetty.

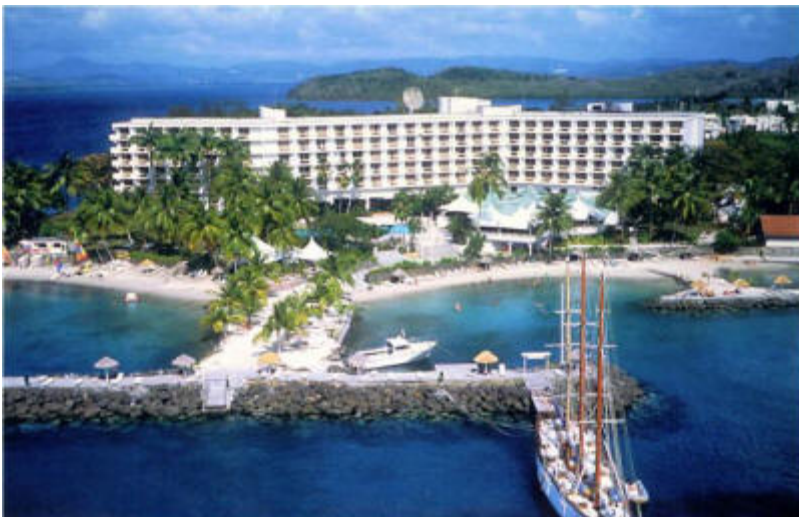
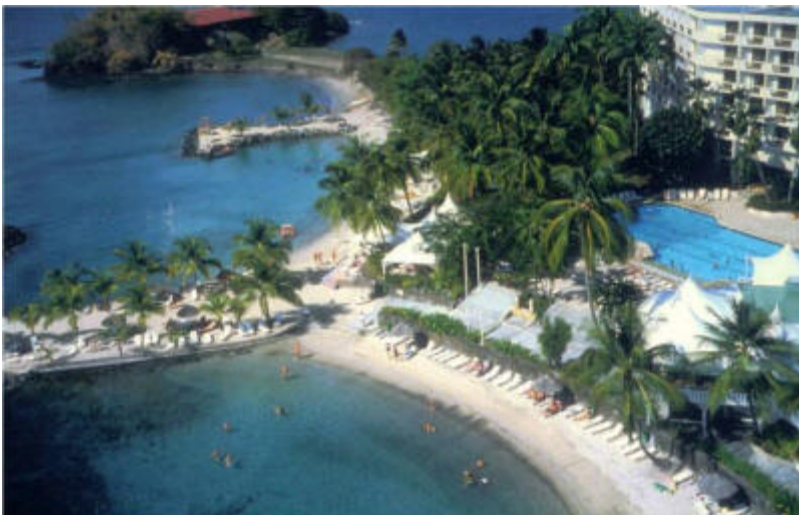
◀ This, and the following, photo show the same area after the project completion; a final layer of sand and landscaping has been added. The effective placement of **groynes** can also be seen along the front edge of the jetty.

A 240 foot long **seawall** was also built between the two jetties.

A layer of 14 oz. non-woven **geotextile fabric** was placed along the tops of the jetties after the boulders / core material had been position, to keep the beach sand from merging between the boulders.

4,500 metric tons of sand was then brought in to **re-nourish** the beaches.

A **sand grain size analysis** was performed beforehand so has to identify and replenish the existing shoreline with size-matched sand, thus *naturally* improving the existing beach.
