## Six Case Study Examples of Beach Creating and Restoration Projects

Managed by: Cliff Juillerat

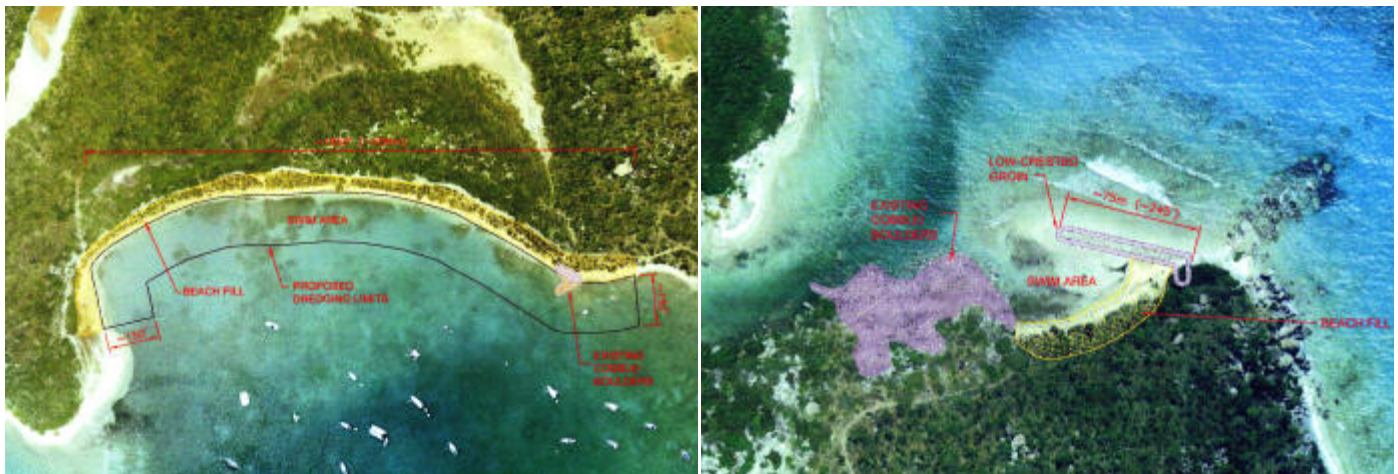
▲ Aerial views of proposed beach restoration and or developments. ▲

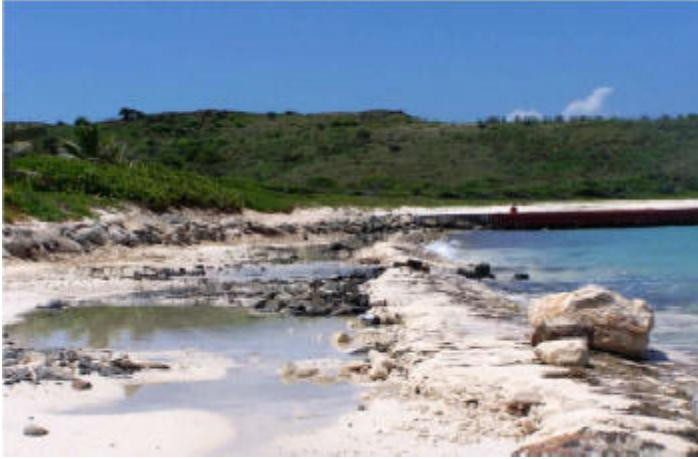
Image 1

▲ A view of the beach "before" the restoration project began. Note, the beach rock(s) along the water's edge.

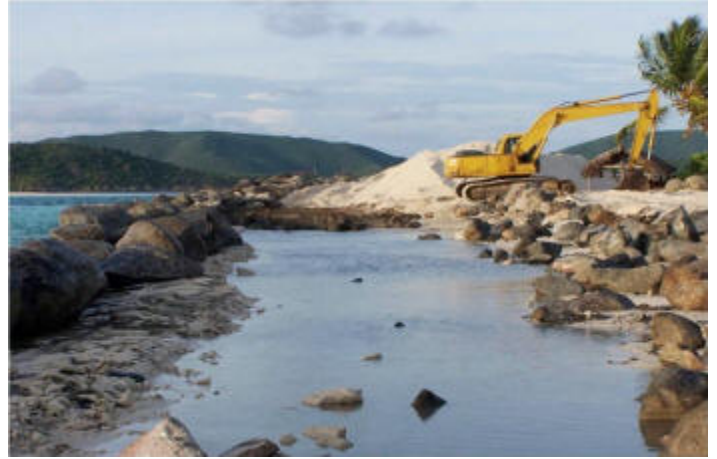
Image 2

▲ Work in progress creating a new, wider beach-front.

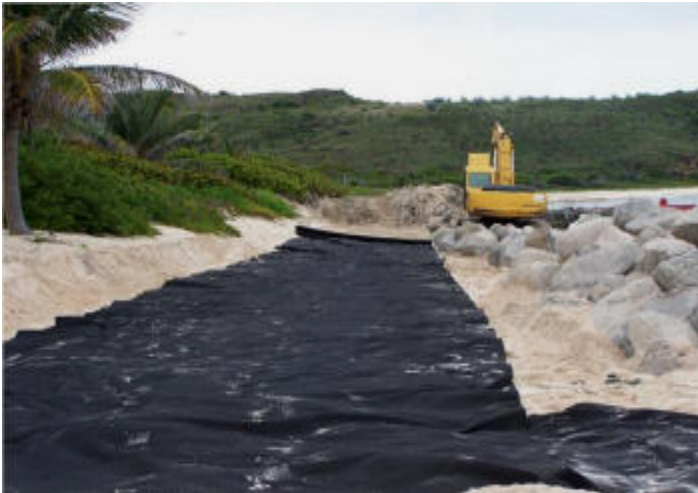
Image 3

▲ Placement of non-woven 14 oz. geotextile fabric on the ground of the newly created beach. Width of material varies between 10 > 18 meters wide to 400 meters in length. The geotextile allows water to pass under the new land area without eroding the sand.

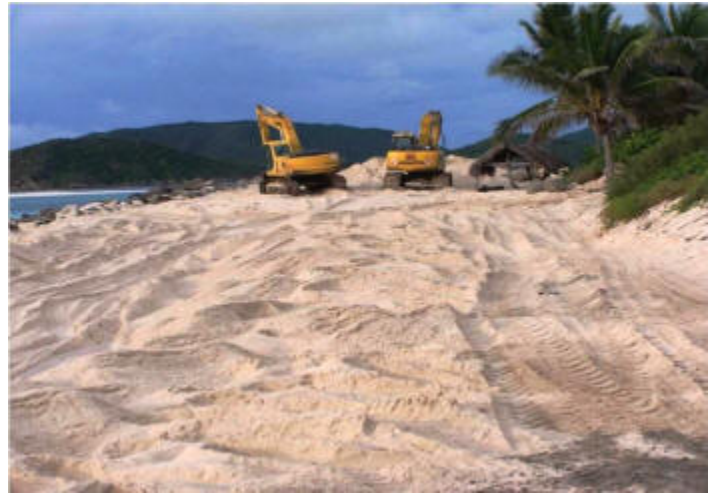
Image 4

▲ Construction of beach: 24 meters wide x 400 long

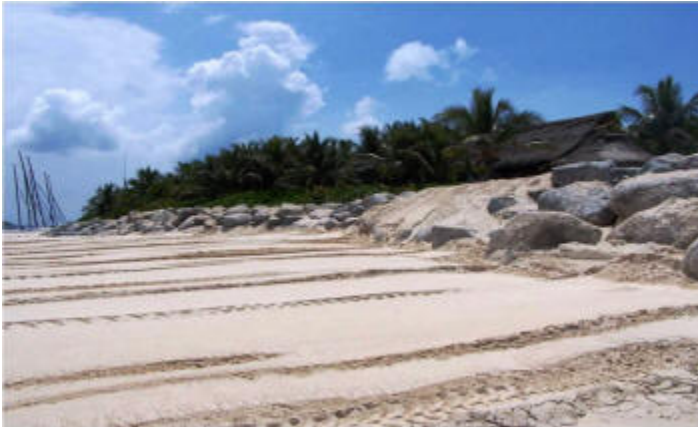
Image 3

◀ Renourished beach front running along the property's seawall. -- The seawall was constructed several years prior to the beach renourishment project in an effort to save the wall and protect a new, multi-million dollar swimming pool. The pool was located just behind the palm trees, approximately two meters from the wall. Prior to the project, the seawall was in danger of collapsing per erosion caused by swell waves & storm surges.

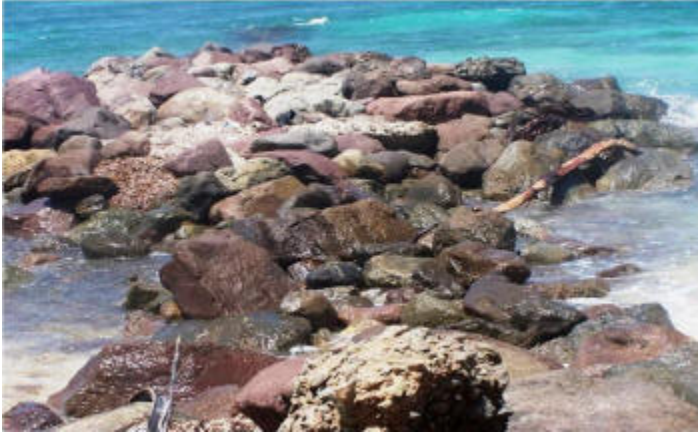
Image 6

◀ Broken groyne

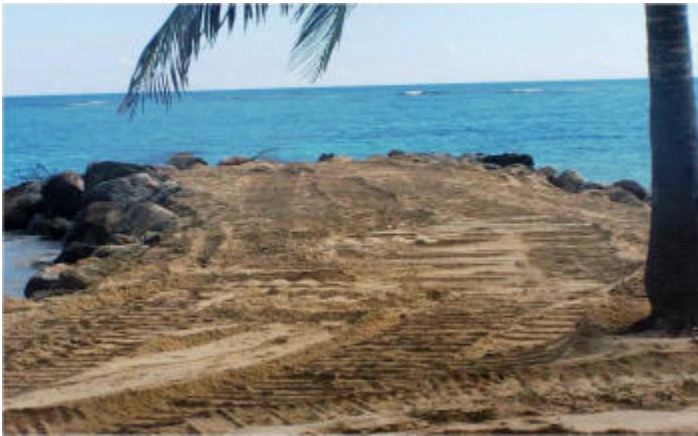
Image 7

◀ Same groyne after restoration & enlargement.  
The area was later used as an area  
for wedding parties and lunch.

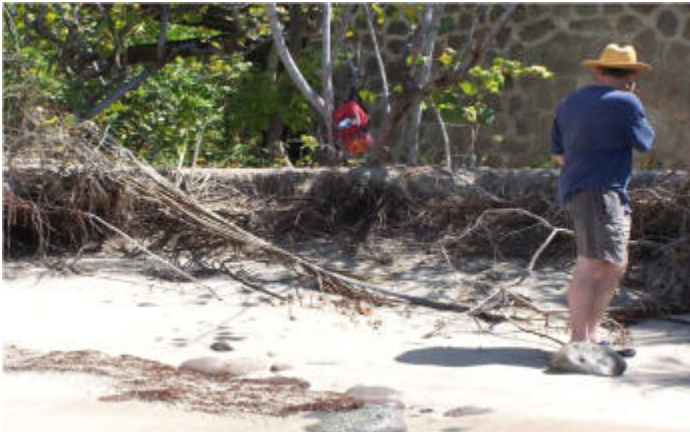
**Image 10**

▲ *Close up view* - Severe beach erosion was beginning to undermine the soil directly in front of the house (seen in background) and was within one meter of the structure.

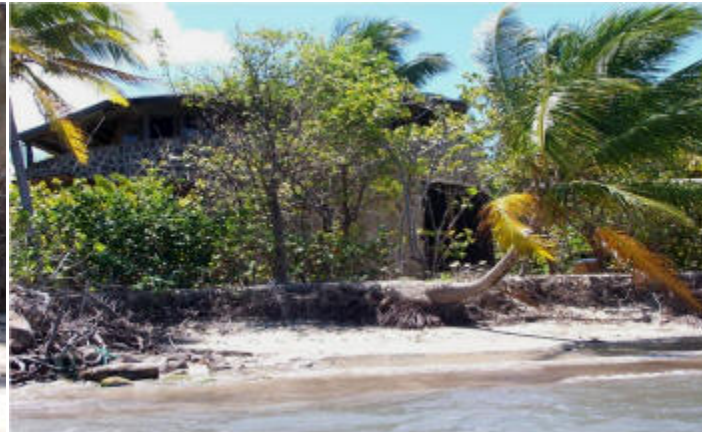
**Image 11**

▲ *Wide angle view* – dwelling and erosion.

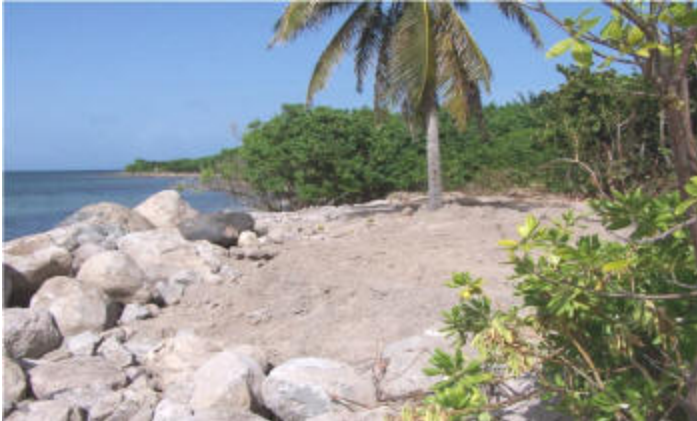
Image 12

◀ The area *AFTER* the placement of the non-woven geotextile fabric (covered by a layer of sand), held in place by a newly constructed seawall, and *BEFORE* the final placement of cap sand (top surface of the beach.)

The *NEW* beach area is approximately 20 meters wide by 200 meters long.

The seawall was constructed using 3 to 8 m<sup>3</sup> boulders, placed at a 3/1 slope angle to send wave energy back seaward thus protecting the dwelling (located just behind the trees on the right side of the image).

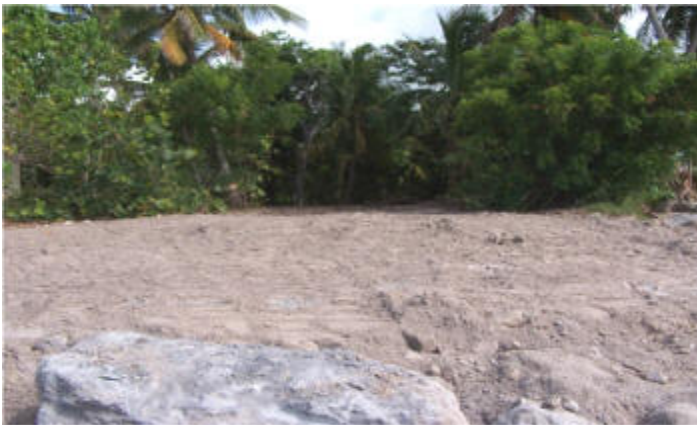
Image 15

◀ ...*before* the cap of beach sand was placed.

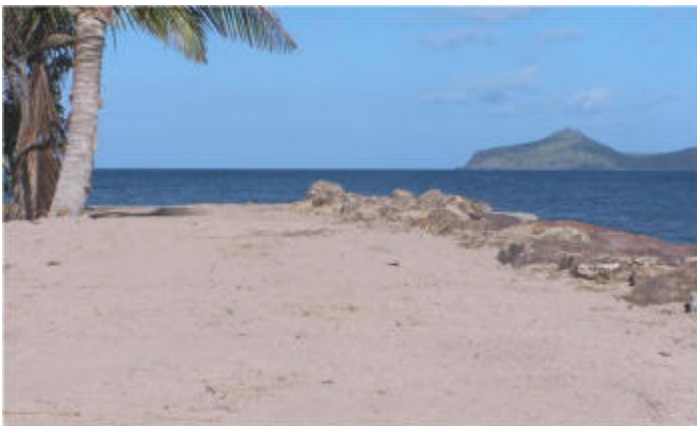
Image 16

◀ ...*after* the 2 meter sand cap was placed upon the base rocks and geotextile material

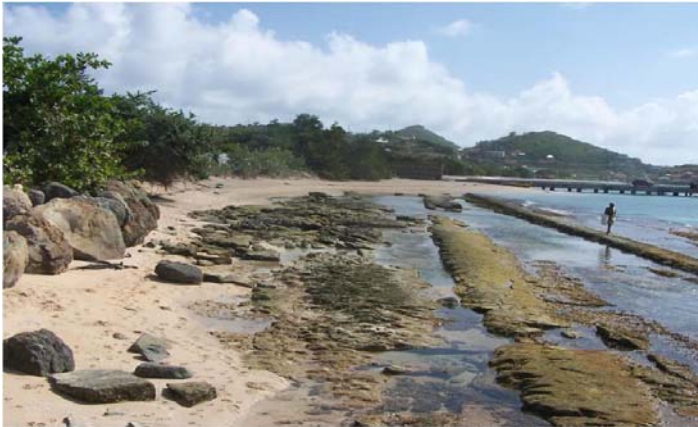
Image 17

◀ This property had lost over 25 meters of beach front due to storm surge and swell waves. Likewise, the near shore coral reefs had also been destroyed, further effecting the loss of sand and destruction of the beach.

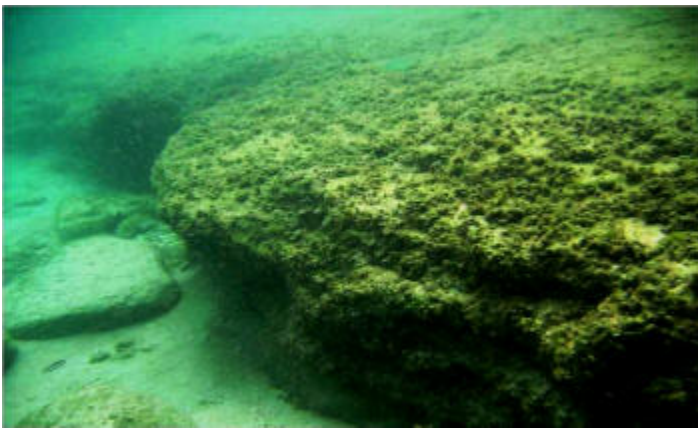
Image 18

◀ This photograph shows the dead coral reef ... notice that the reef rock is completely covered with sand which in turn has blocked sunlight and any potential reef re-growth .

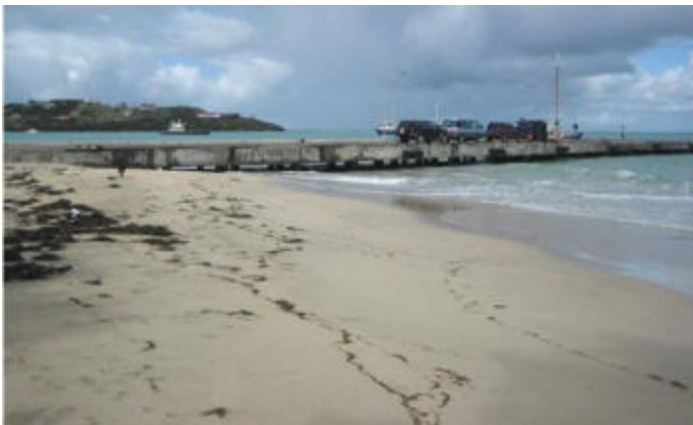
Image 19

◀ Same beach after project completion.

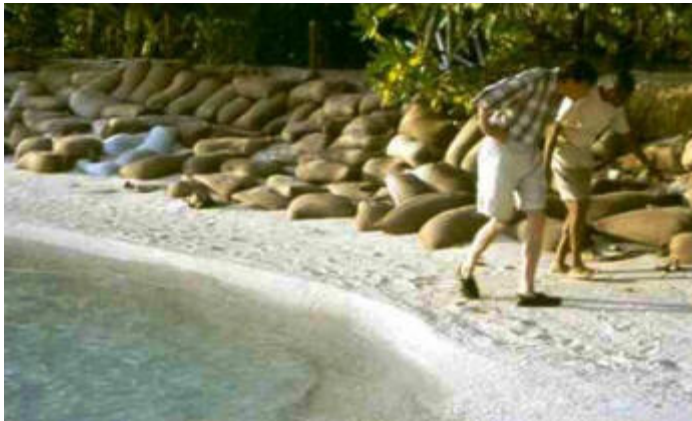
Image 20

▲ Beach and erosion control prior to the start of the project. Sand bags cover a meter high cliff eroded from the sand and the adjoining trees are collapsing over them.

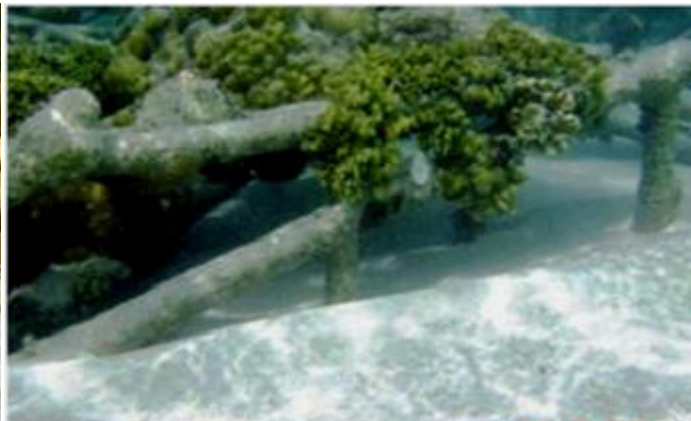
Image 21

▲ Rapid growth of minerals and corals on the Biorock shore protection reef slows down waves and traps sand, thus helping control erosion and increasing the length / width of the entire beachfront.

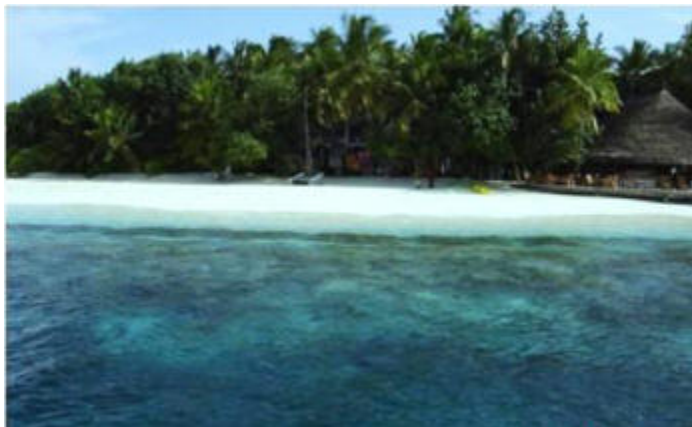
▲ Image 22

Fifteen meters of new beach *grew* within a few years behind the Biorock shore protection reef. Notice that the sandbags previously used for protection and erosion control, are gone.

The newly grown beach, stabilized behind the Biorock reef (see foreground, dark area in water) and was not affected by the tsunami that passed over the island in December, 2004.

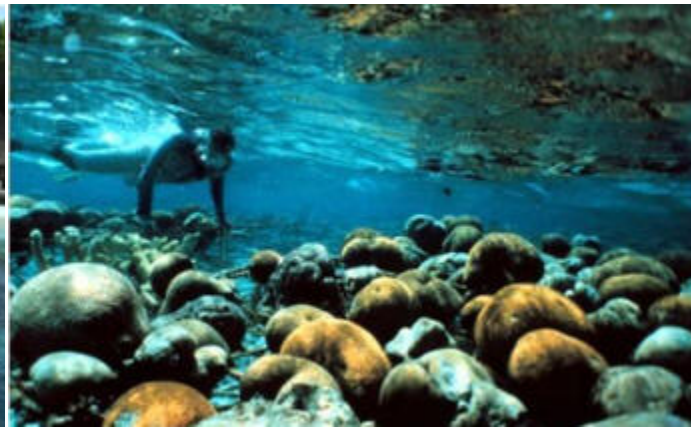
▲ Image 23

Biorock shore protection reef, Ihuru Island, Maldives.

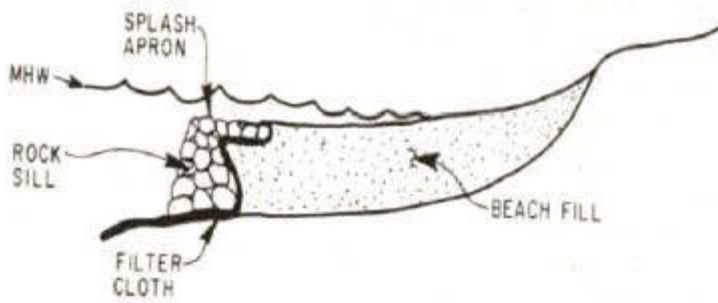
▲ Image 23

Drawing showing the construction features of a perched beach.

- creates a wider beach at locations where the natural beach has become too narrow and low due to the erosion of the coastal profile at specific location(s), where the coastline is fixed.
- have many of the same qualities as natural beaches, and are submerged thus, do not intrude on the view of the waterfront.
- are an appropriate erosion control measure where a beach is desired and sand loss is often rapid.

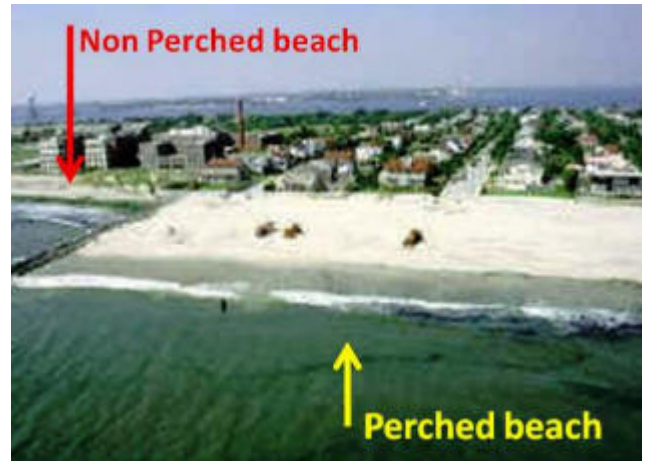
▲ Image 24

Compare a non perched beach to a the final results of restoration project utilizing a perched beach.
